Preliminary damage survey results for Marion, Jasper and Poweshiek Counties

The following is a preliminary assessment for the damage that occurred over Marion, Jasper and Poweshiek Counties on April 6th.

Event Date: April 6, 2010

Event Type: Straight-line damaging winds with embedded large hail.

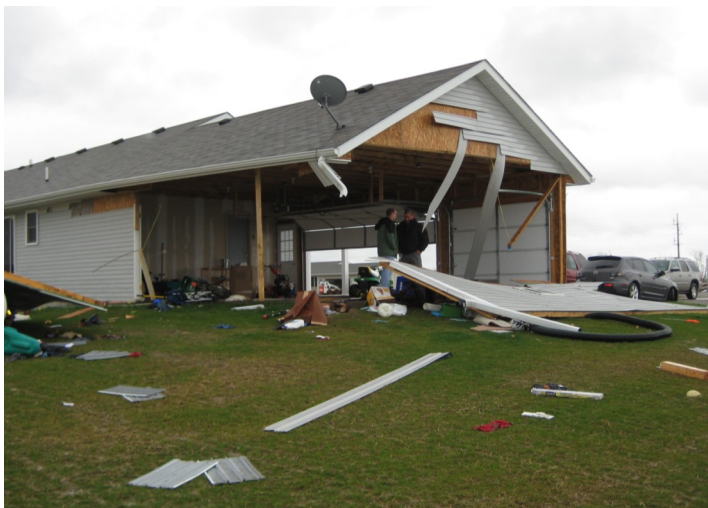
Image 1
Garage damage to a home outside of Pella, IA.

Discussion/Damage: A very strong thunderstorm moved northeast through Marion, Jasper and into Poweshiek county late Tuesday afternoon. Large hail broke a few windows out of homes on the northwest side of Knoxville. An isolated area of strong winds was located 5 miles northwest of Pella. The greatest damage in this location was 2 walls of an attached garage blown out (image 1). The garage walls were only attached with nails into the concrete foundation. Wind coming in from the open garage door was able to blow the 2 walls out from bottom to top. There was also some hail damage with broken windows and holes in vinyl siding. One open-ended farm shed lost a roof just down the road, which was blown approximately half a mile, and two trees were blown down (image 2). Wind speed estimates in this area are consistent with 75 to 85 mph straight-line winds.

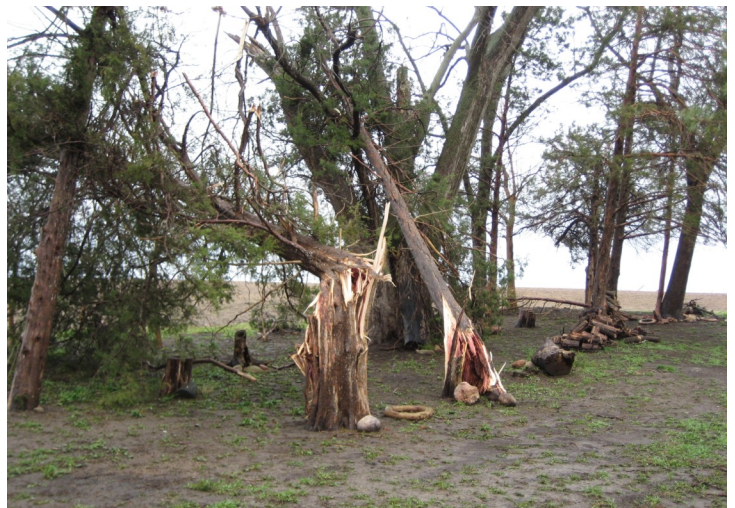
Image 2
Tree damage outside of Pella, IA

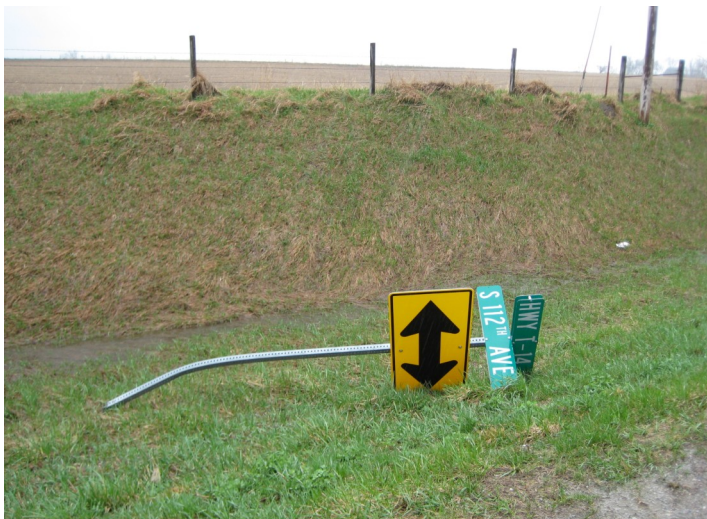
Image 3
Street sign blown over outside of Sully, IA.

The storm continued to move north with little evidence of strong wind damage, with the exception of one bent over street sign and downed power poles near Sully (image 3).

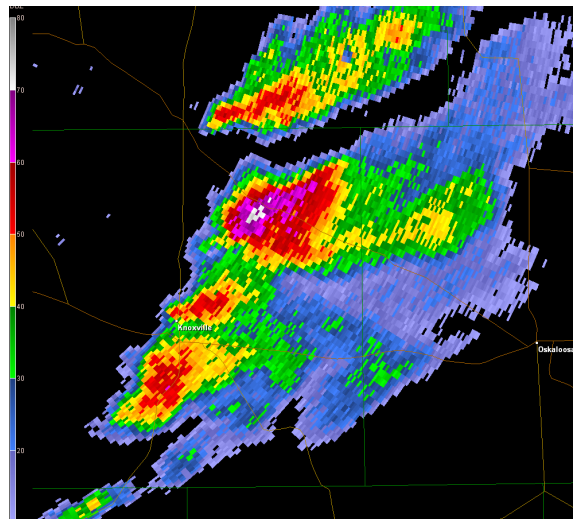
Image 4
Radar image of storm near Pella, IA.

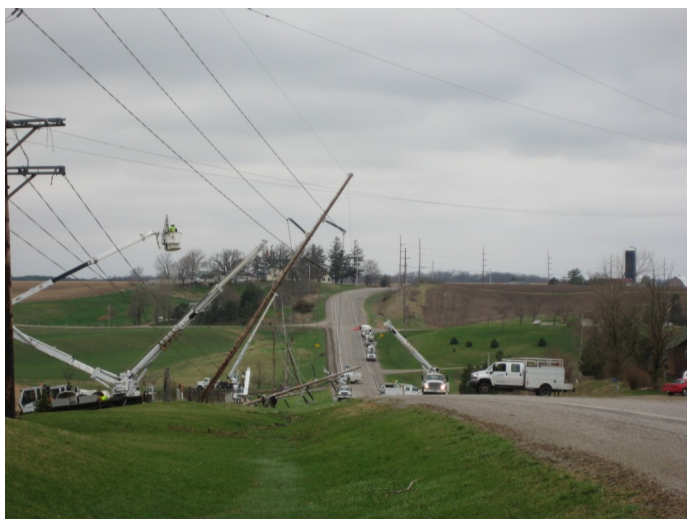
Image 5
Power poles blown down near Grinnell, IA.

Numerous farm out buildings suffered significant damage on the west side of Grinnell along with downed power lines in the region (image 5). Several houses suffered significant vinyl siding and window damage (image 6). Another house had both garage doors blown in and the west side wall removed and deposited north of the location (image 7). Several other south facing garage doors were blown in as well, along with several trees which were snapped or uprooted over the region. The damage ended 2 miles north of Grinnell. Damage indicators suggest damaging straight-line winds of 95 to 105 mph.

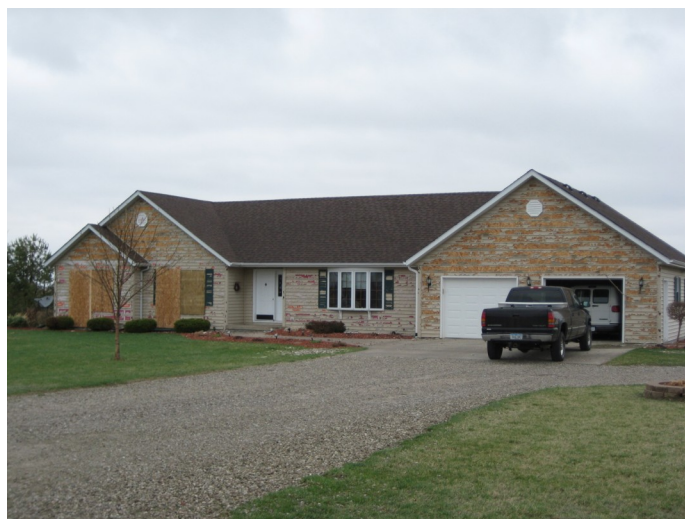
Image 6
Vinyl siding damage to home near Grinnell, IA.

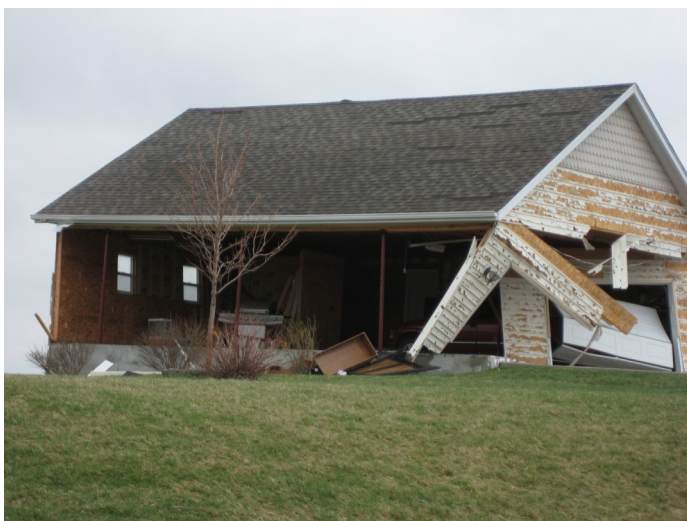
Image 7
Garage damage to home near Grinnell, IA.

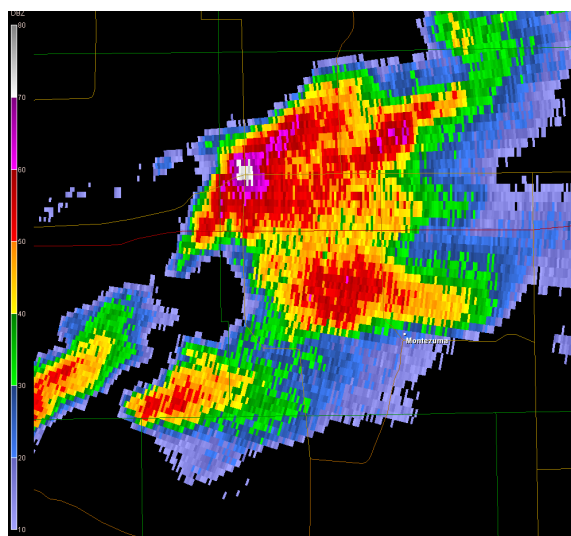
Image 6
Radar image of storm near Grinnell, IA.
